NBSIR 78-1415

Fire Endurance Tests of Residential Walls Containing Branch Circuit Wiring - Preliminary Findings

Lionel A. Issen

February 1978

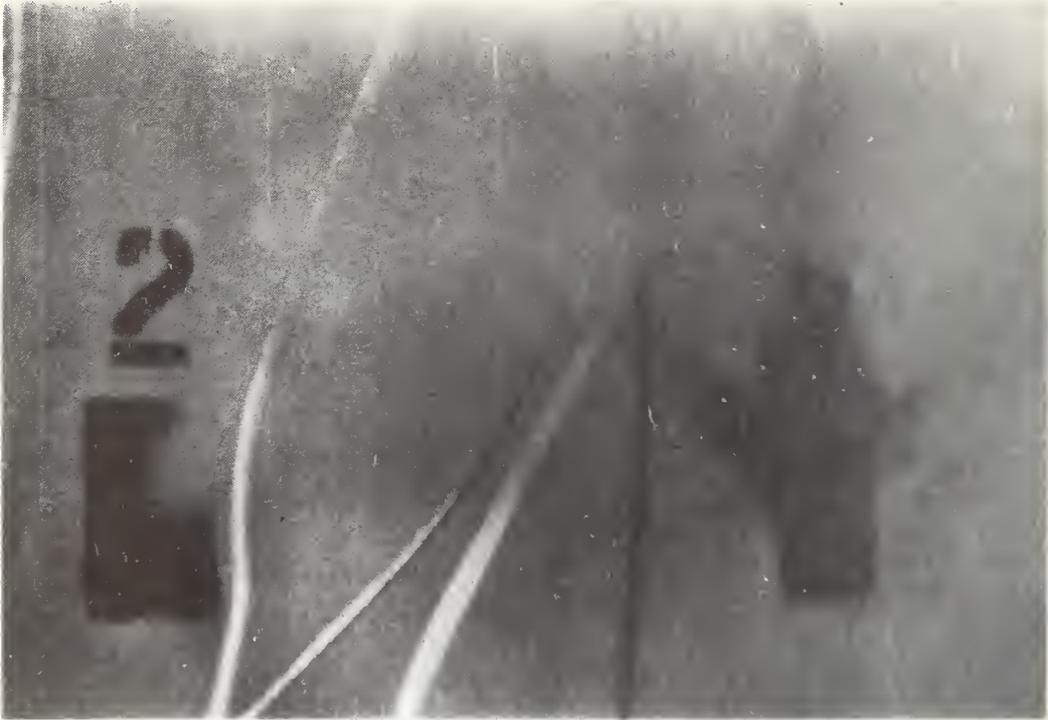
Figure 42. Test FE 1 - Smoke coming out of AC (2) insulated and NM uninsulated (3) switches

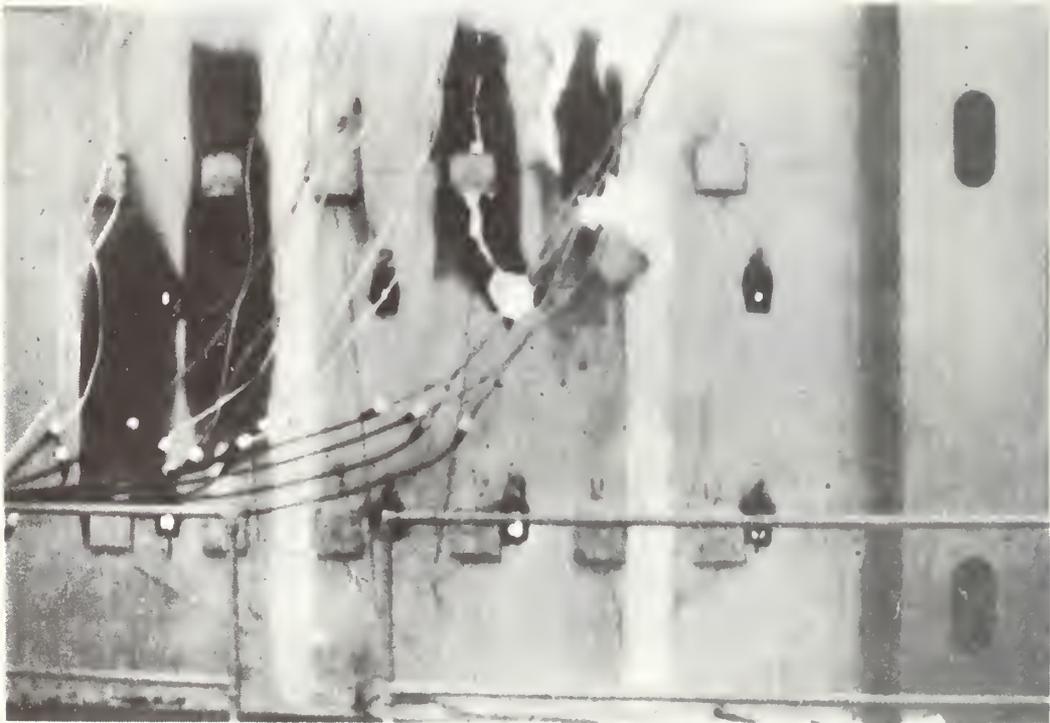
Figure 43. Test FE 1 - Front of furnace at end of test

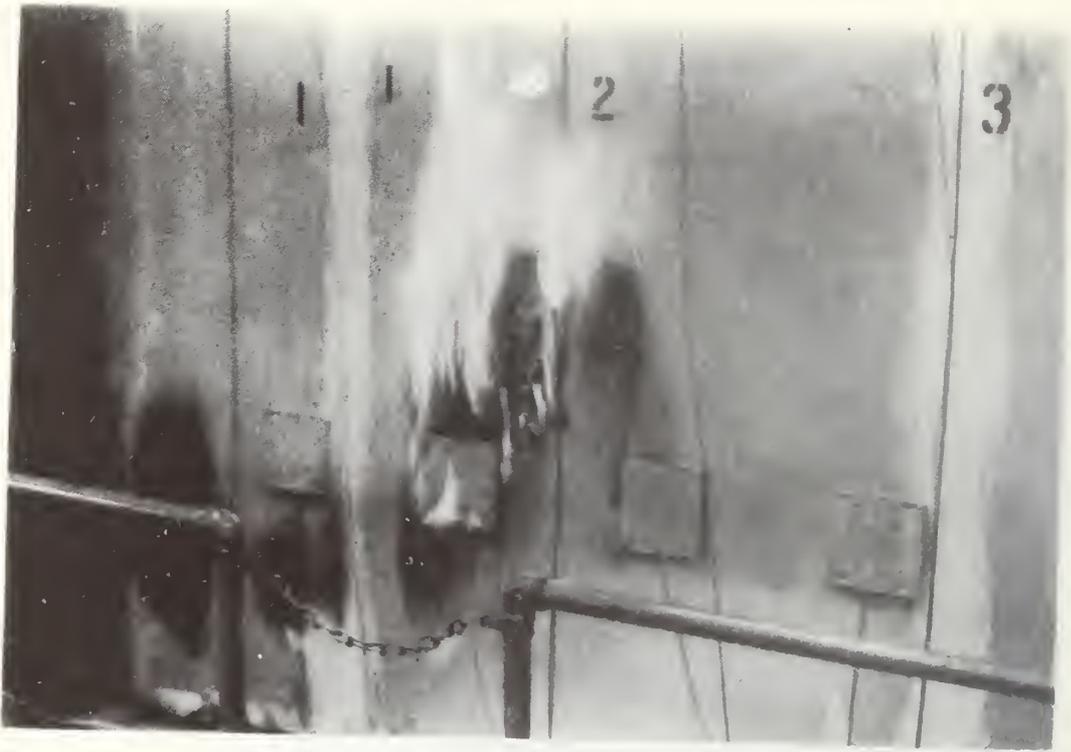
Burn-through at the middle of the wall just after the test was ended, see figure 45.

Figure 45. Test FE 2 - Burn-through at end of test
